# 1999 Kocaeli and Düzce, Turkey, Earthquakes

Lessons for  
Local Governments on  
Hazard Mitigation  
Strategies and  
Human Needs  
Response Planning

March 2002

ASSOCIATION OF BAY AREA GOVERNMENTS

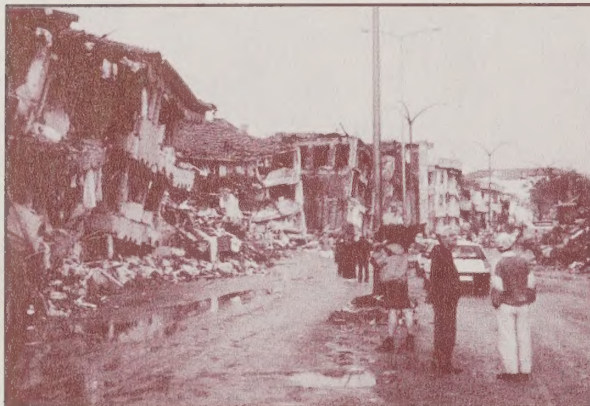
Street scene in Adapazai  
following the Kocaeli, Turkey,  
earthquake

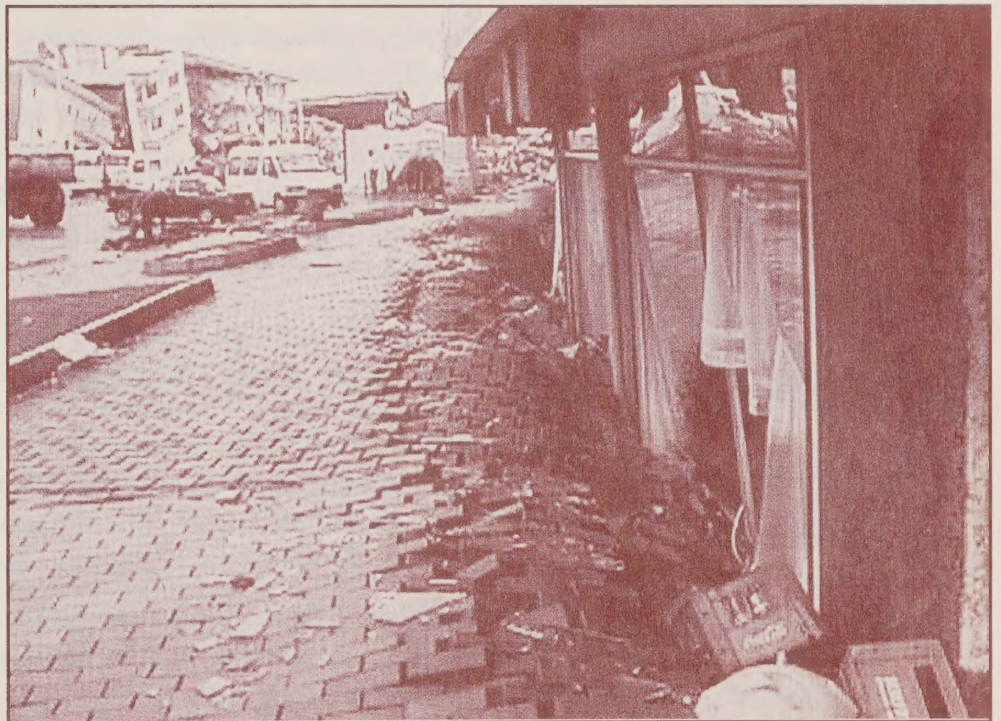
- ◆ fault rupture (causing the partial or total collapse of approximately 100 concrete frame buildings),
- ◆ liquefaction (when granular or sandy materials saturated with water can behave like a liquid, instead of like solid ground),
- ◆ coastal failures (including the failure at Degirmendere, where a large coastal slide carried a hotel into the bay, killing several people), and
- ◆ a small tsunami.

Example of liquefaction damage in the 1999 Kocaeli, Turkey Earthquake

Although shaking hazards are most effectively addressed with building codes, other earthquake hazards, including fault rupture and coastal sliding, are often best mitigated through land use controls, such as requirements for detailed identification of fault locations and coastal sliding areas followed by set-back restrictions. Again, local governments rarely institute the requirements, but almost always will be asked to implement them. As with code enforcement, land use implementation recommendations should be coupled with adequate continuing education and training for the local government employees who will be enforcing increasingly complex regulations.
